Scale, bacteria, and corrosion control for cooling towers

## Case Study: Scale control in hard water, 3 Chemical-free systems compared

System: Cooling Tower, Chiller  
 Installation: March 2015  
 Issue: Scale accumulation in chiller and cooling tower  
 Benefits: Restored heat transfer efficiency, reduced energy consumption, reduced corrosion, prevented scale, extended equipment life

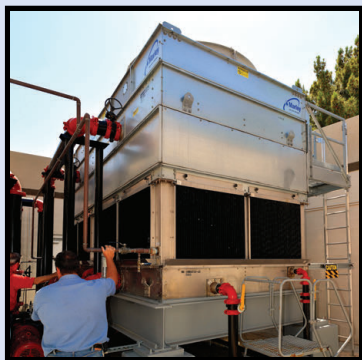
Marley MD Cooling Tower

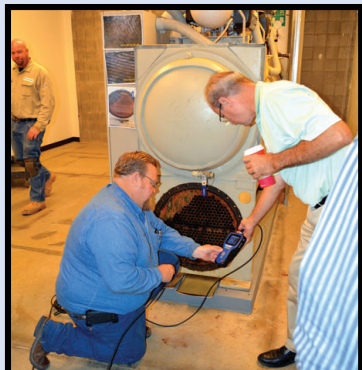
Daikin WMC-290 Chiller

**Chiller Tubes:** Since the Flow-Tech system was installed in March of 2015, the cooling system has not shut off due to high head pressure - even with extremely challenging and varying water quality. Each year after the cooling season ends, borescope pictures have been taken to view the rifling inside the chiller tubes to verify that optimal surface area is present for heat transfer.

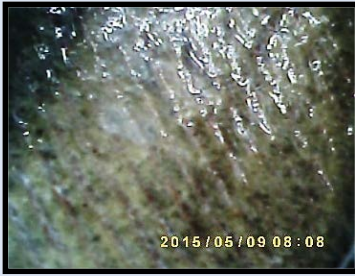
Boroscope images inside Daikin WMC-290 Chiller Tubes

With Griswold (5/9/2015)

From 2009 to 2014, they experienced scale, biofilm, and high corrosion rates in their cooling tower and chiller that lead to decreased heat transfer efficiency and caused the system to shut down due to high head pressure. Borescope images of the chiller tubes and inspection of the cooling tower showed substantial scale accumulation and biological film. The scale that had accumulated with Dolphin and Griswold had to be removed with acid.

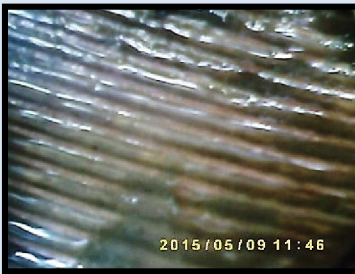
After acid wash (5/9/2015)

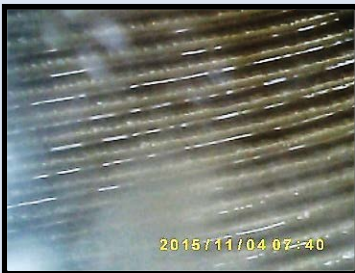
1 full cooling season with Flow-Tech (11/4/2015)

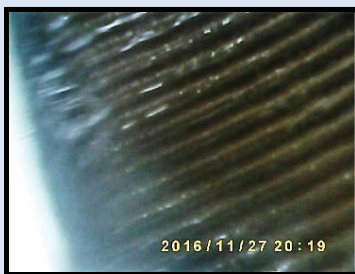
2 full cooling seasons with Flow-Tech (11/27/2016)

Flow-Tech kept the chiller tubes clean for two full cooling seasons even with very hard and varying water quality where other systems failed. Keeping chiller tubes clean maximized heat transfer efficiency and eliminated unexpected shutdowns due to high head pressure.

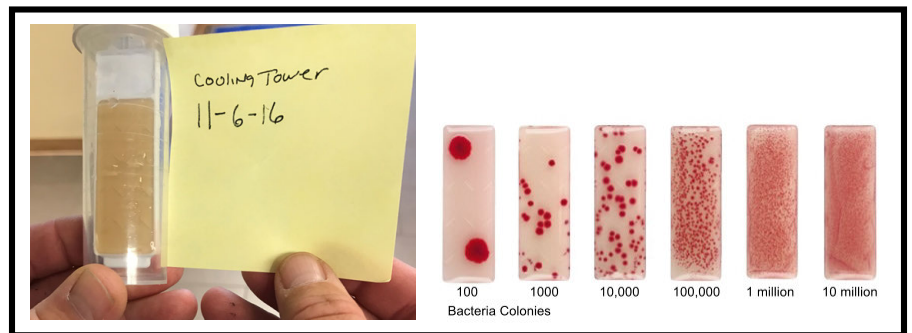
Bacteria dipslide test showing no detected bacteria

**Bacteria:** While biofilm was observed with previous technologies, Flow-Tech removed and prevented biofilm. By encapsulating bacteria and damaging their cell walls Flow-Tech held bacteria counts to non-detectable levels.
