Domestic Hot Water Case Study:
Apartment Heater Scale Prevention

System:	200,000/BTU Cyclone Water Heaters
Installation:	July 2016
Benefits:	Energy savings and longer equipment life

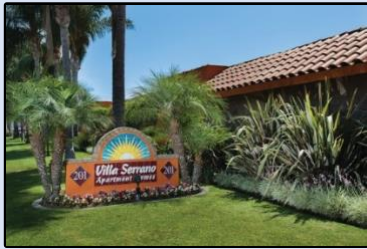
Flow-Tech was installed
at
Villa Serrano
apartments.

In July 2016, Flow-Tech was installed on one pair of water heaters; one heater was a new replacement and one was pre-existing. The pair of heaters support 26 apartments and a laundry facility.

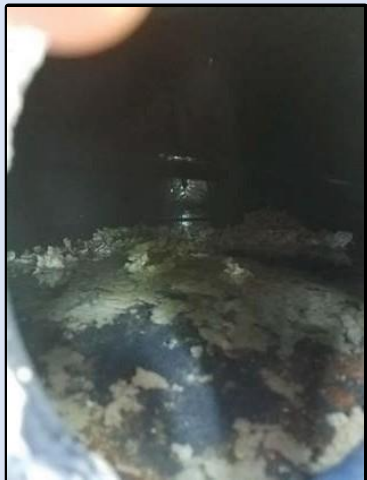
After four months, the heater
tubes remained clean and kept
their energy star ratings.

After four months, the Flow-Tech treated heaters were compared to another pair of heaters at the complex. In the replacement heater, no scale formation was seen. In the pre-existing heater, about 4" of scale residue was seen at the bottom of the tank. The scale was dislodging from the previously scale-covered walls and becoming soft powder, allowing for a flush of the system to remove the minerals.

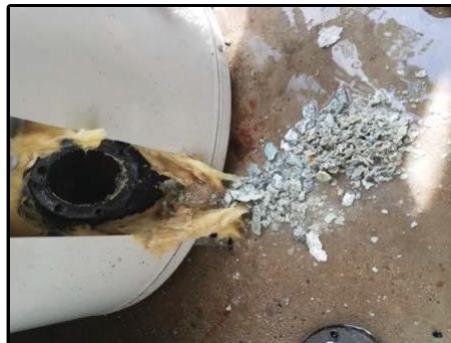
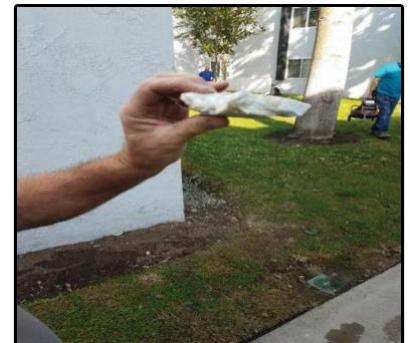
The heaters not treated with Flow-Tech had typical hard scale that needed to be manually broken off.

A series of untreated heaters were opened. Hard encrusted scale was found inside along their tubes and walls. An attempt to flush these systems did not remove the scale, leading to the need to manually removing the scale in 3" thick pieces.
